*Baytree Community
Development District*

Workshop Meeting Agenda

2023 Annual Engineering Report

Date: June 20, 2023
To: Peter Armans, District Engineer, Dewberry
From: James Byrne, Staff Environmental Scientist, Dewberry
Subject: Baytree Community Development District (CDD)
Stormwater Inspection Results (June 2023); SJRWMD Permit No. 4-009-16578-7

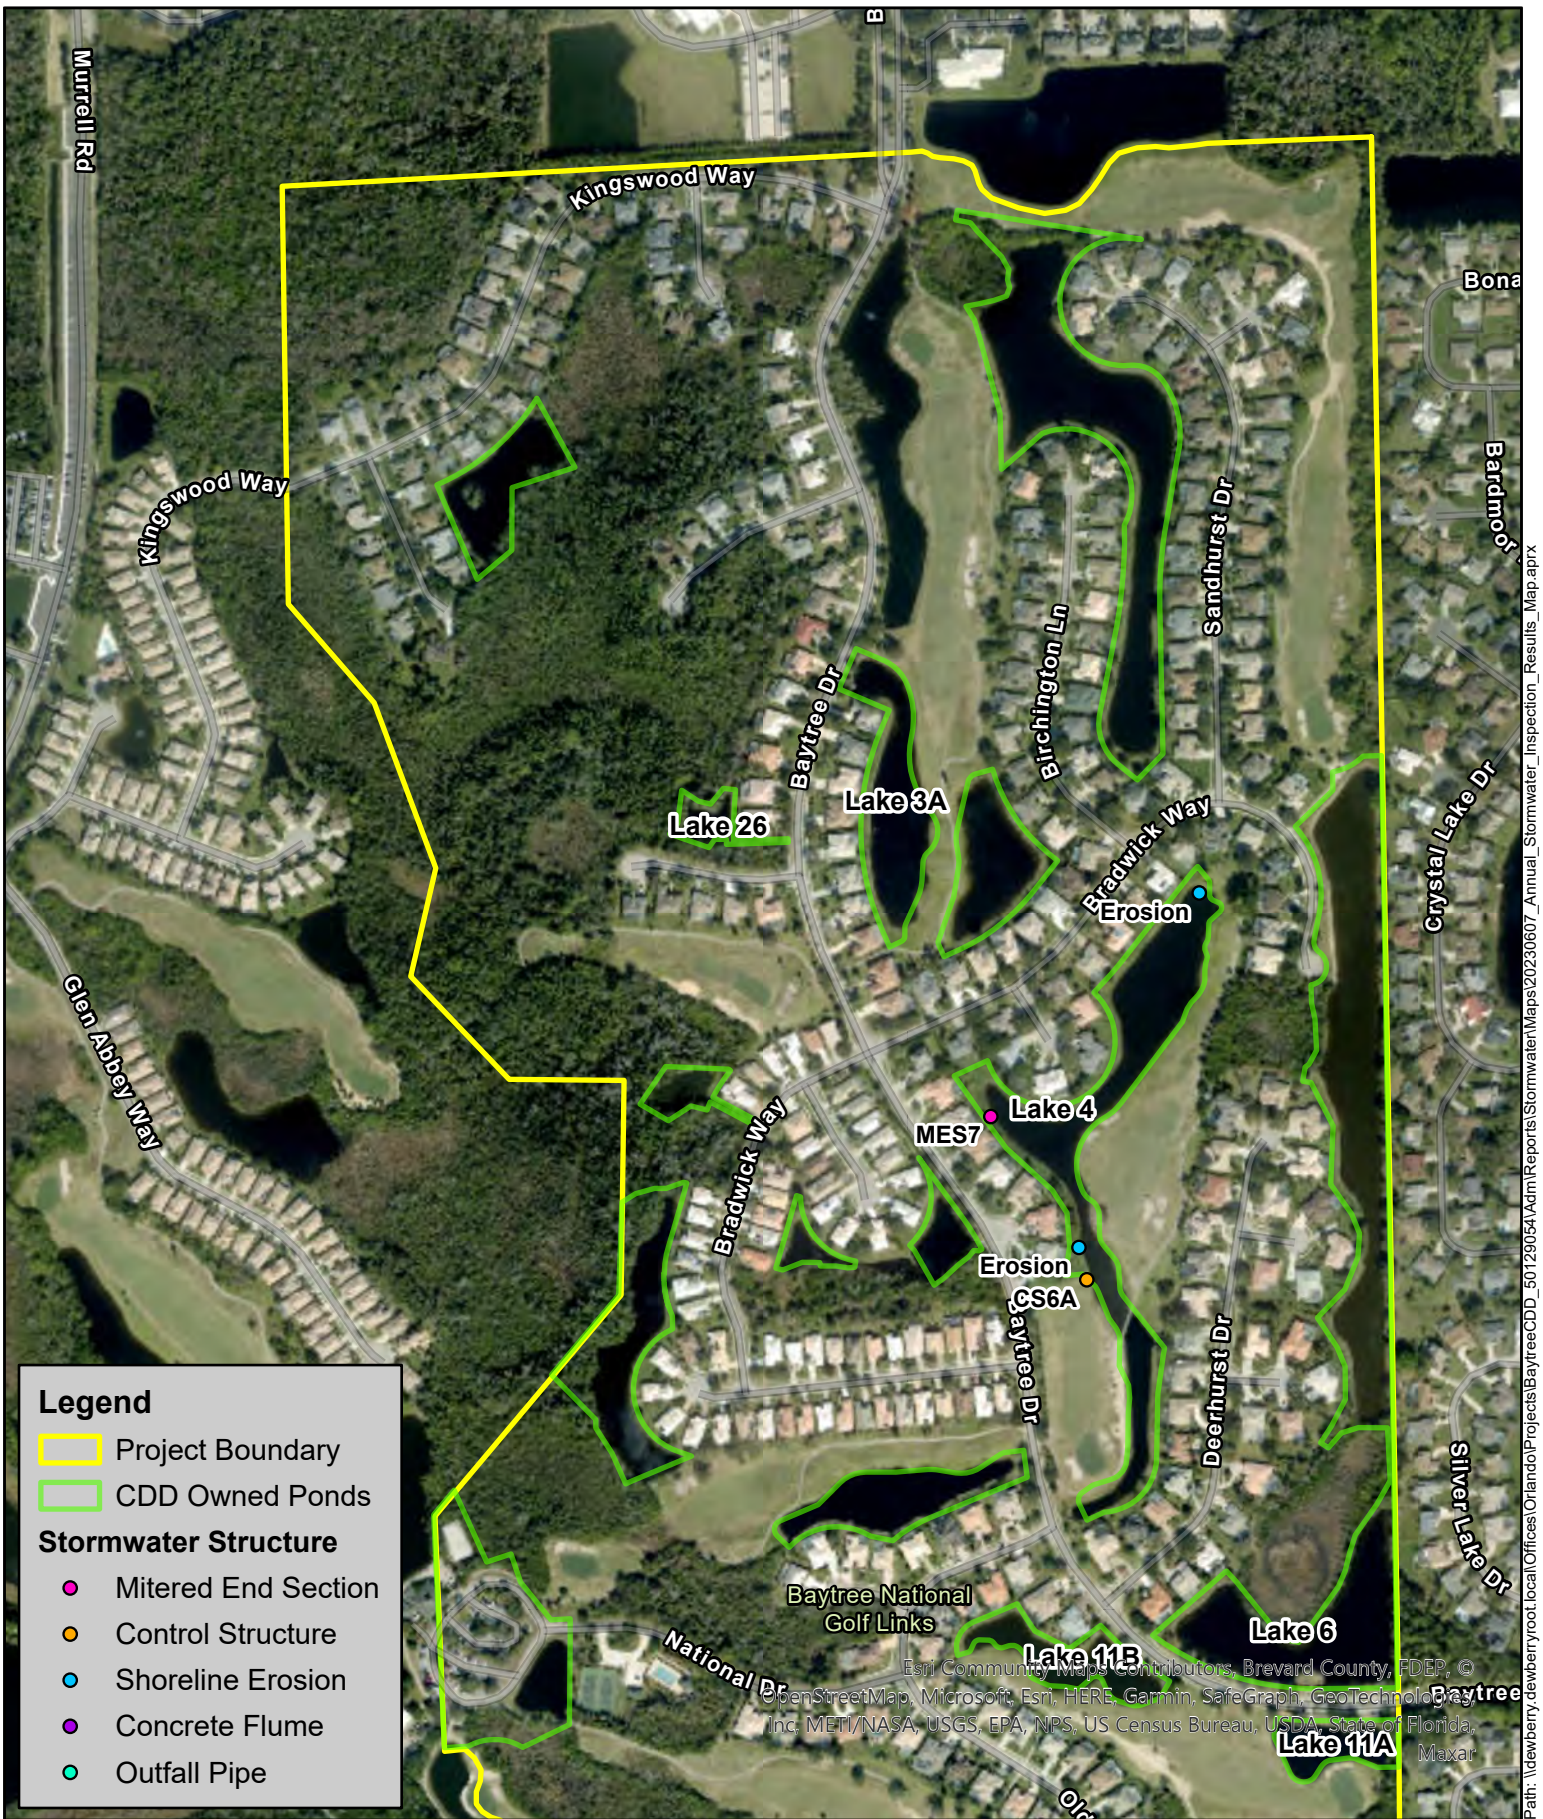
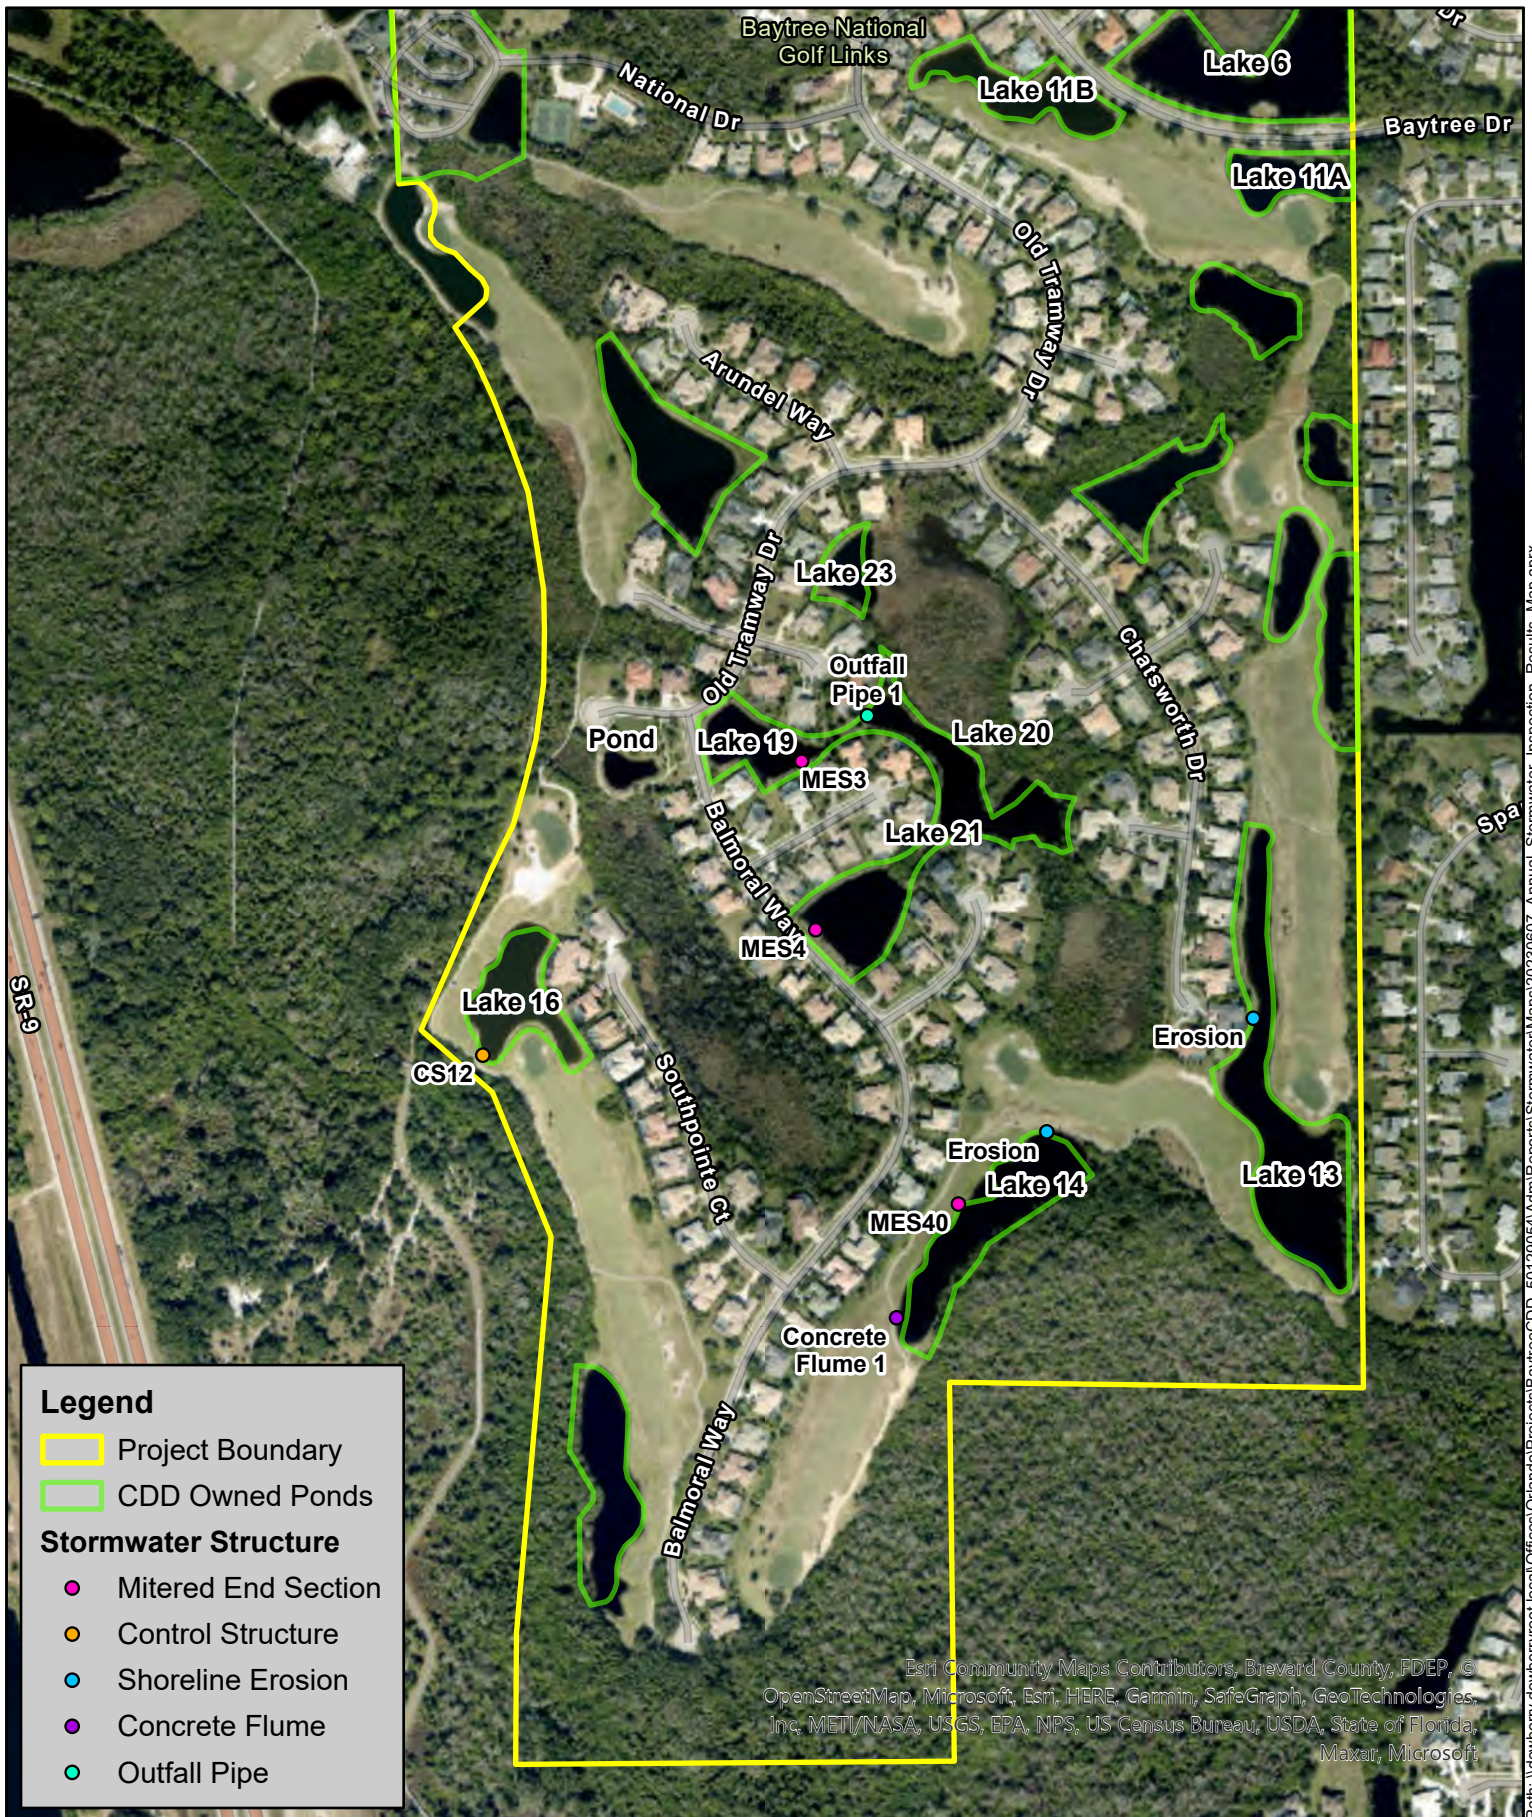
2023 Annual Stormwater Inspection Results Map

Location	Structure	Condition	Comments
Lake 4	Shoreline Erosion	Needs attention	Erosion issues along shoreline
Lake 4	CS6A	Needs attention	Missing grate
Lake 4	Shoreline Erosion	Needs attention	Erosion issues along shoreline
Lake 4	MES7	Needs attention	Erosion issues along sides of structure
Lake 13	Shoreline Erosion	Needs attention	Erosion issues along shoreline
Lake 14	Concrete Flume 1	Needs attention	Cracked at base of structure
Lake 14	MES40	Needs attention	Erosion issues at top of structure
Lake 14	Shoreline Erosion	Needs attention	Erosion issues along shoreline
Lake 16	CS12	Needs attention	Broken; missing grate
Lake 19	MES3	Needs attention	Sediment buildup inside of structure
Lake 20	Outfall Pipe 1	Needs attention	Debris; sediment buildup around structure
Lake 21	MES4	Needs attention	Erosion issues at top of structure

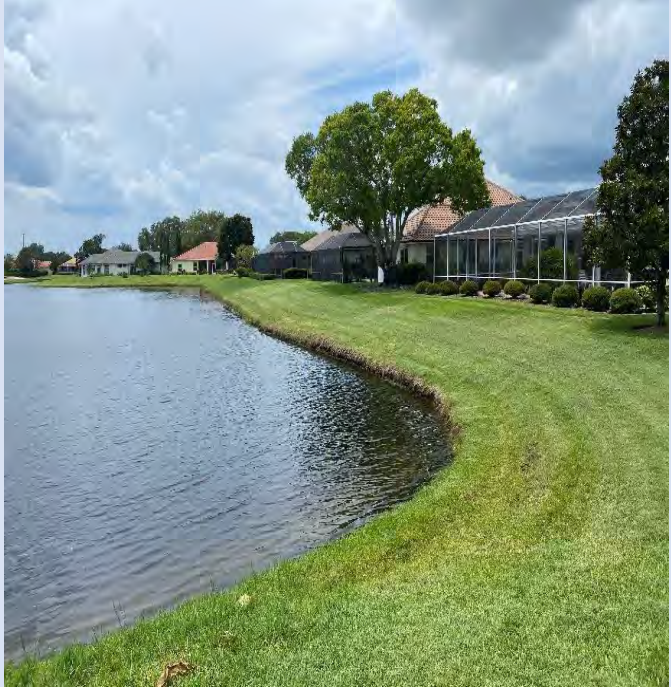
ID	Structure	Condition	Comments	Photo
Lake 4	Shoreline Erosion	Needs attention	Erosion issues along shoreline

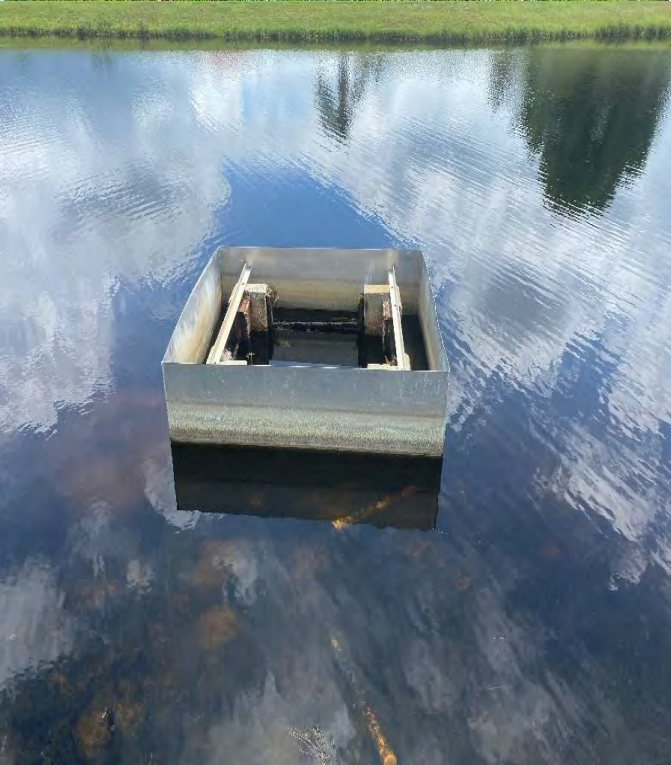
Lake 4	CS6A	Needs attention	Missing grate; erosion issues

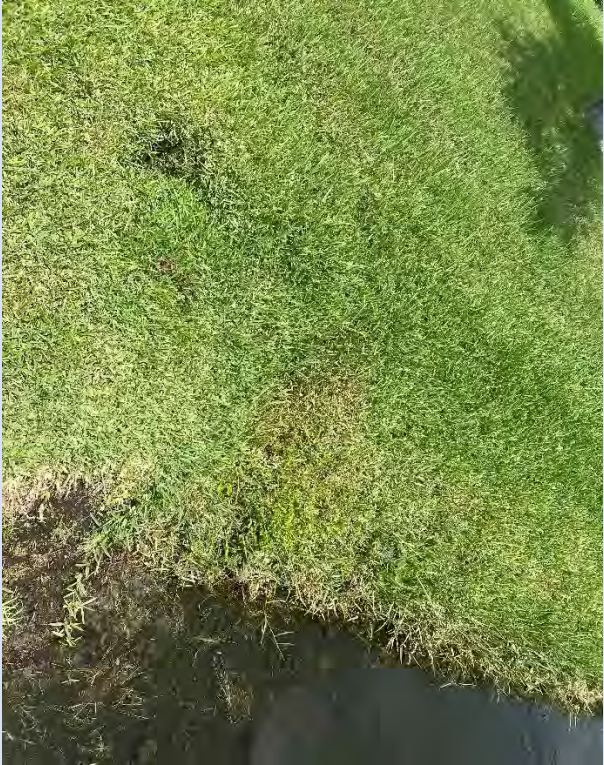
Lake 4	Shoreline Erosion	Needs attention	Erosion issues along shoreline

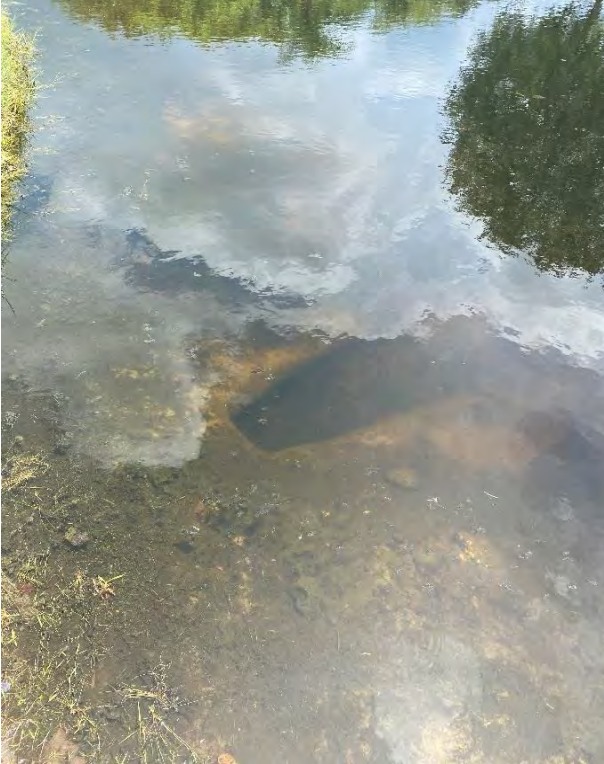
Lake 4	MES7	Needs attention	Erosion issues along sides of structure

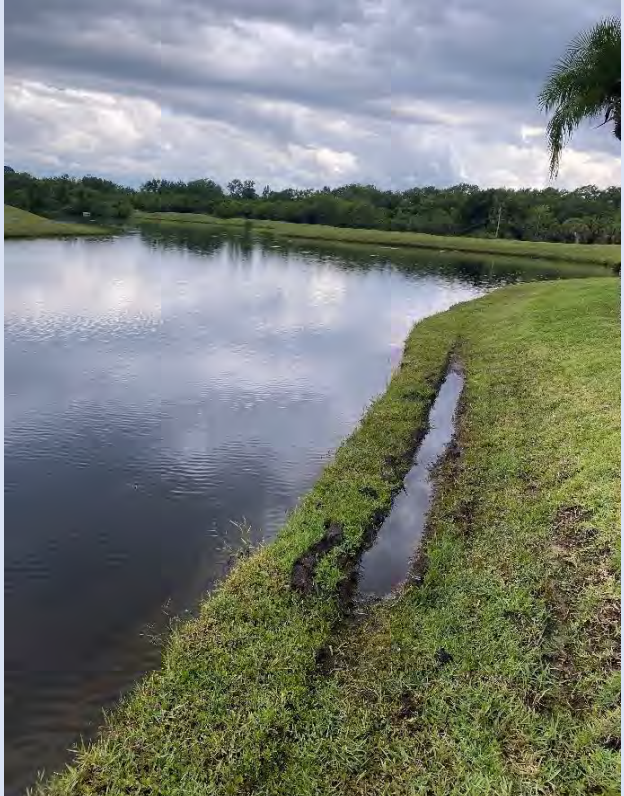
Lake 13	Shoreline Erosion	Needs attention	Erosion issues along shoreline

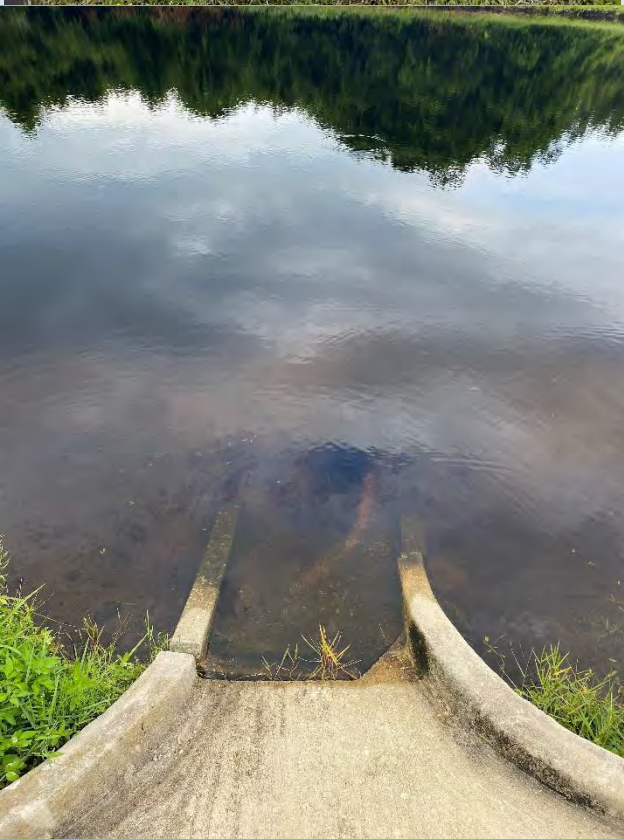
A photograph showing a grassy shoreline of a lake. The water is calm and reflects the sky. There is a visible erosion channel cutting through the grass on the right side of the image.
Lake 14	Concrete Flume 1	Needs attention	Cracked at base of structure

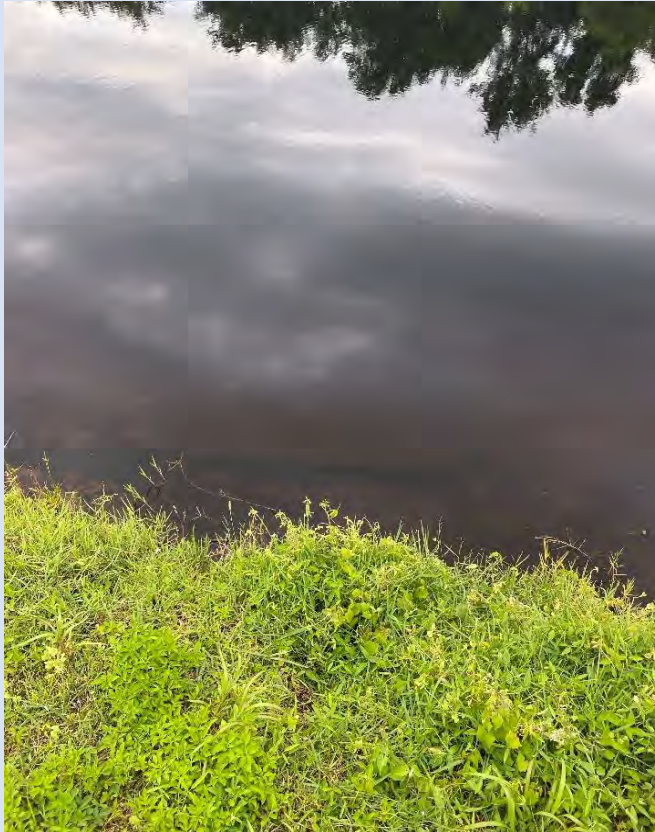
Lake 14	MES40	Needs attention	Erosion issues at top of structure

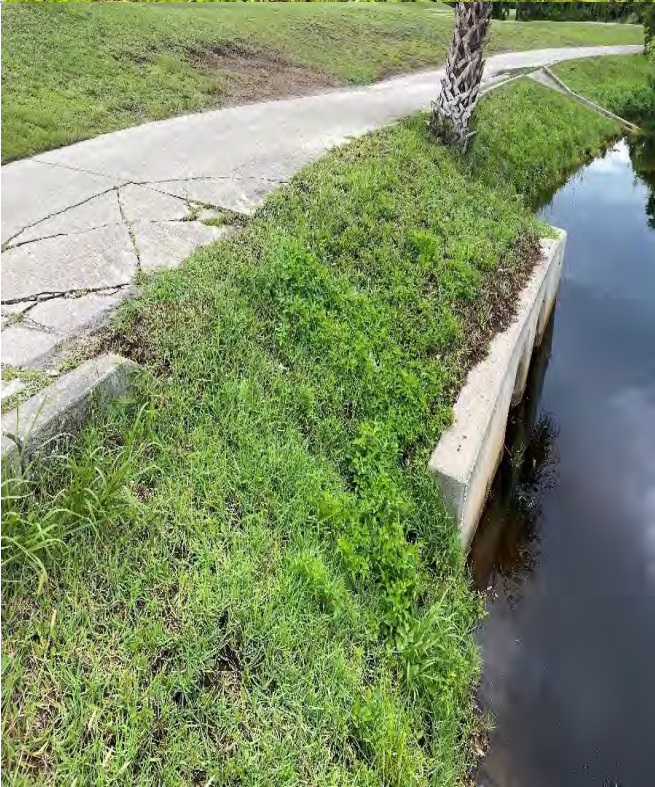
Lake 14	Shoreline Erosion	Needs attention	Erosion issues along shoreline

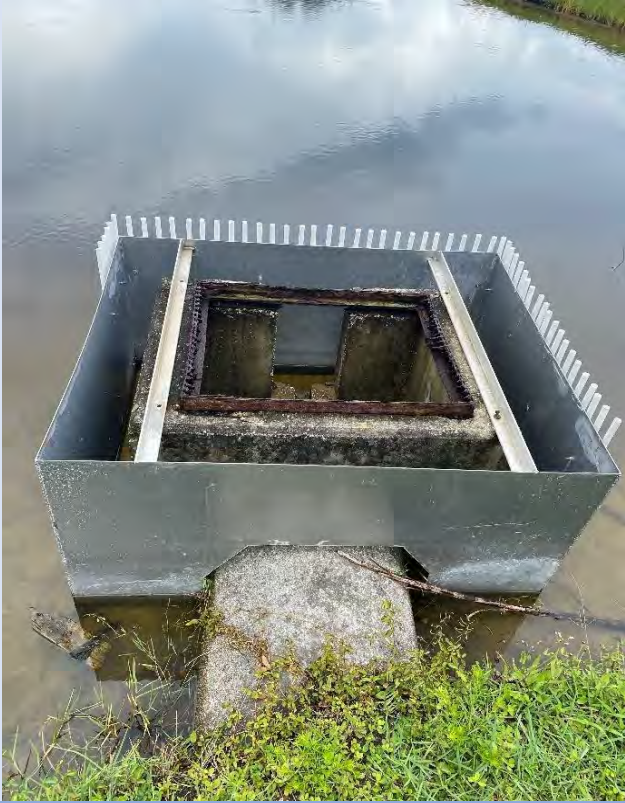
Lake 16	CS12	Needs attention	Broken; missing grate

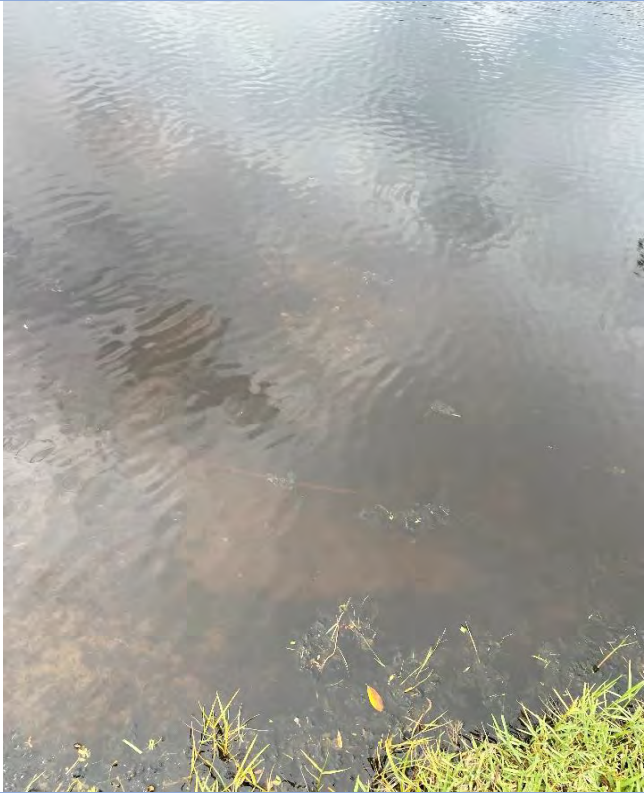
Lake 19	MES3	Needs attention	Sediment buildup inside structure

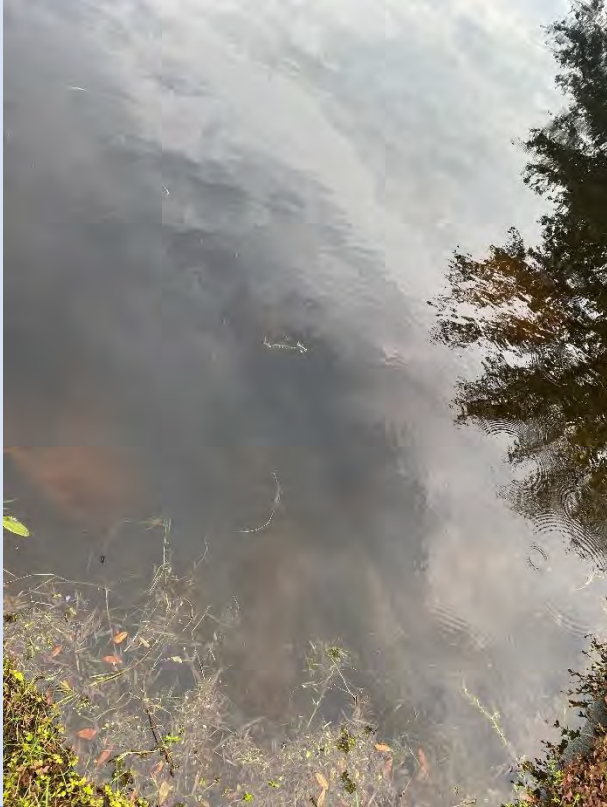
Lake 20	Outfall Pipe 1	Needs attention	Debris; sediment buildup around structure

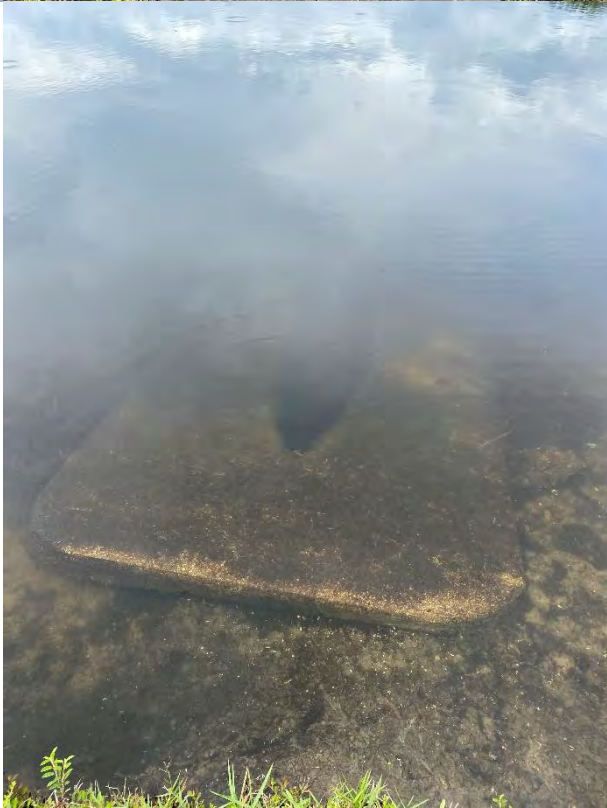
Lake 21	MES4	Needs attention	Erosion issues at top of structure

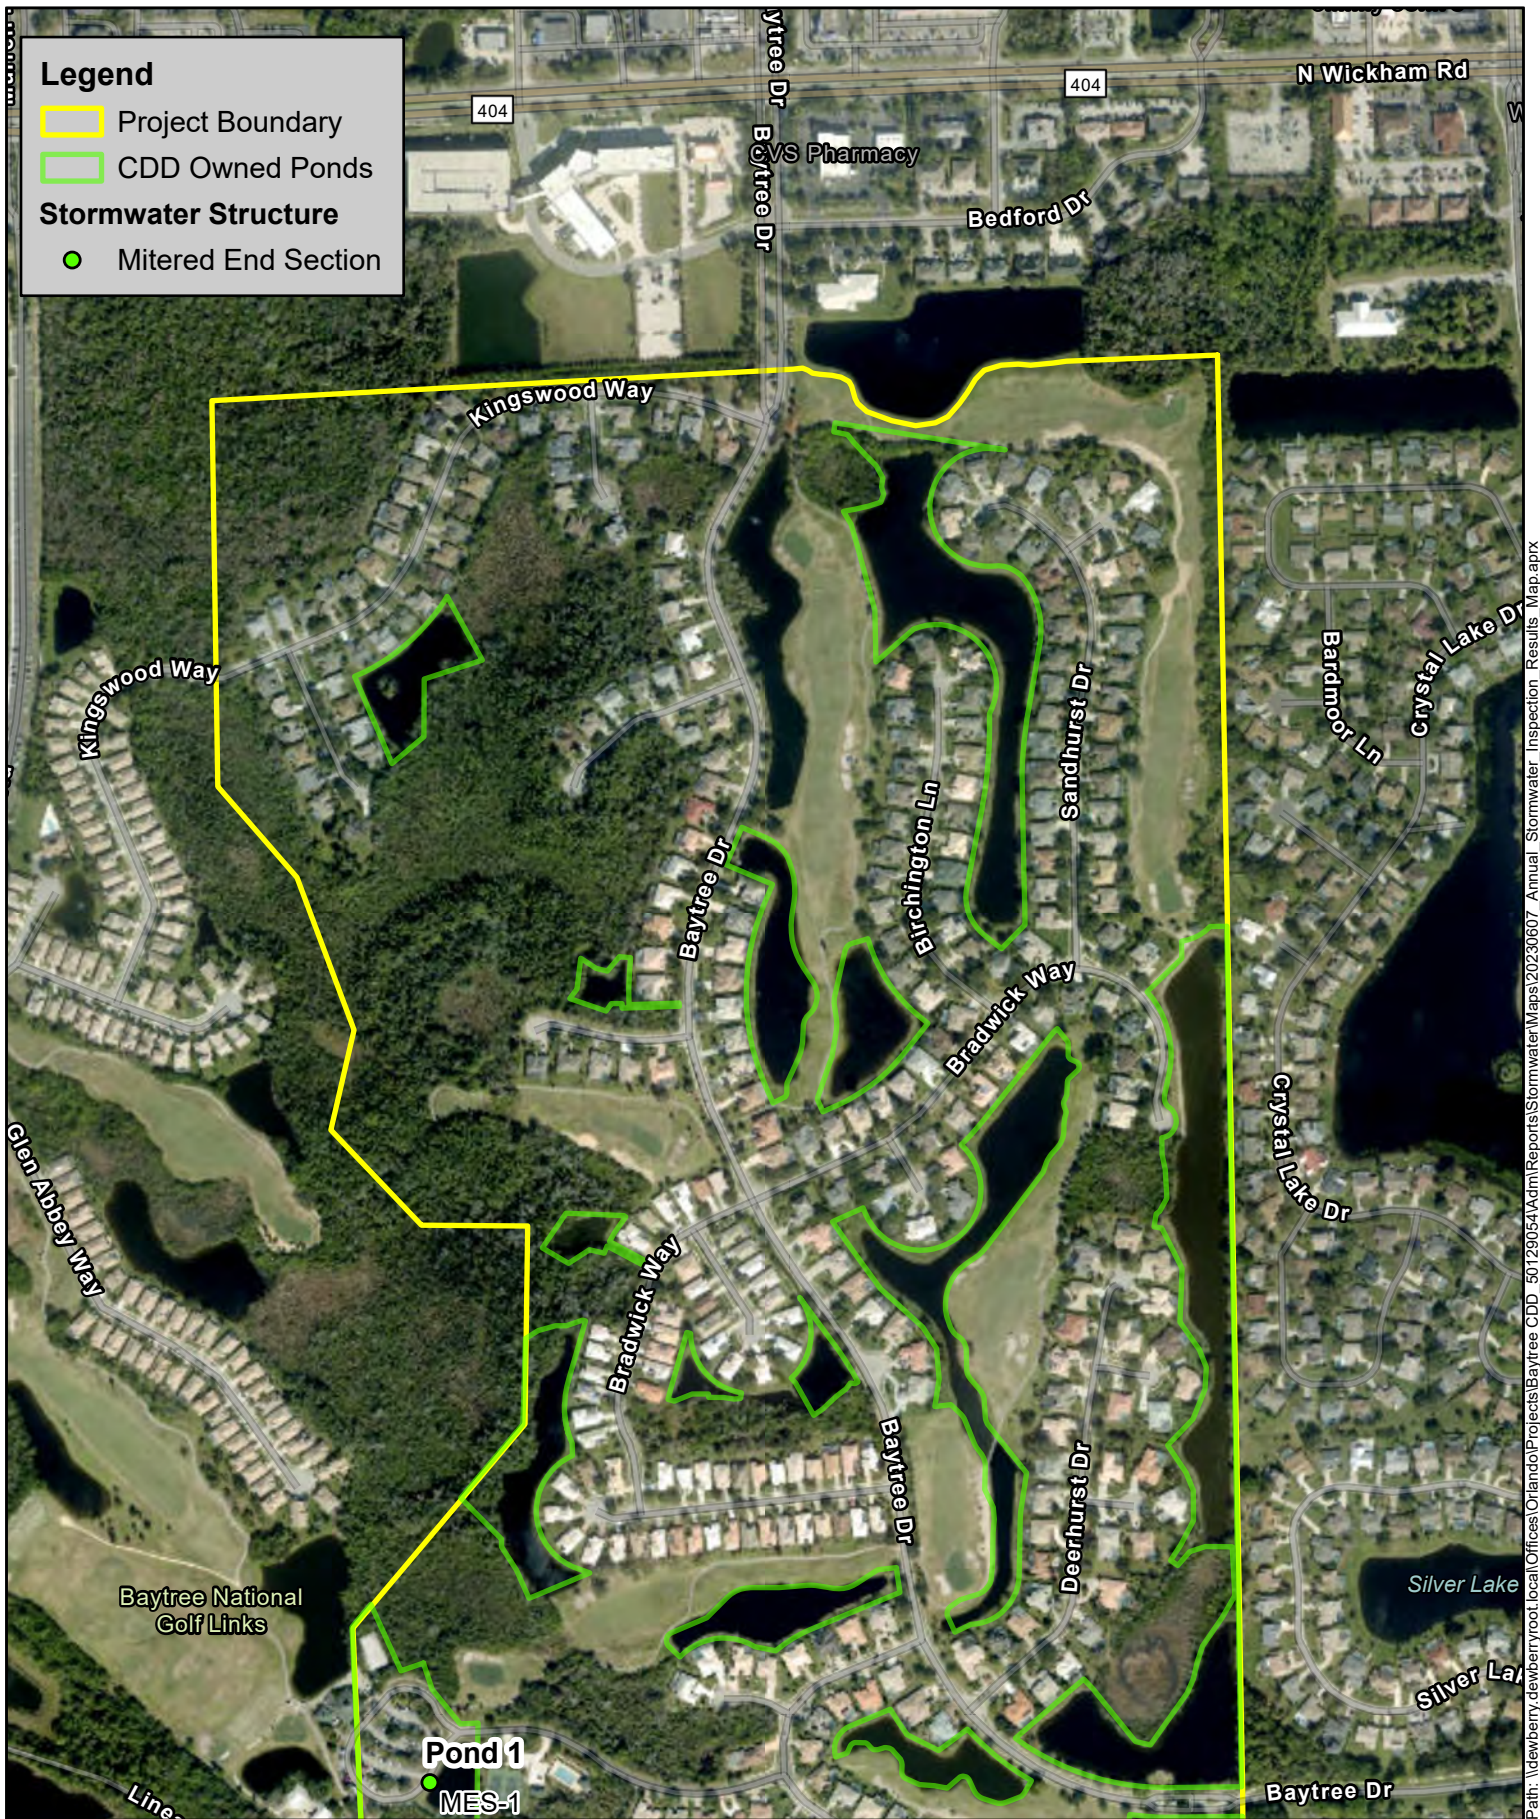
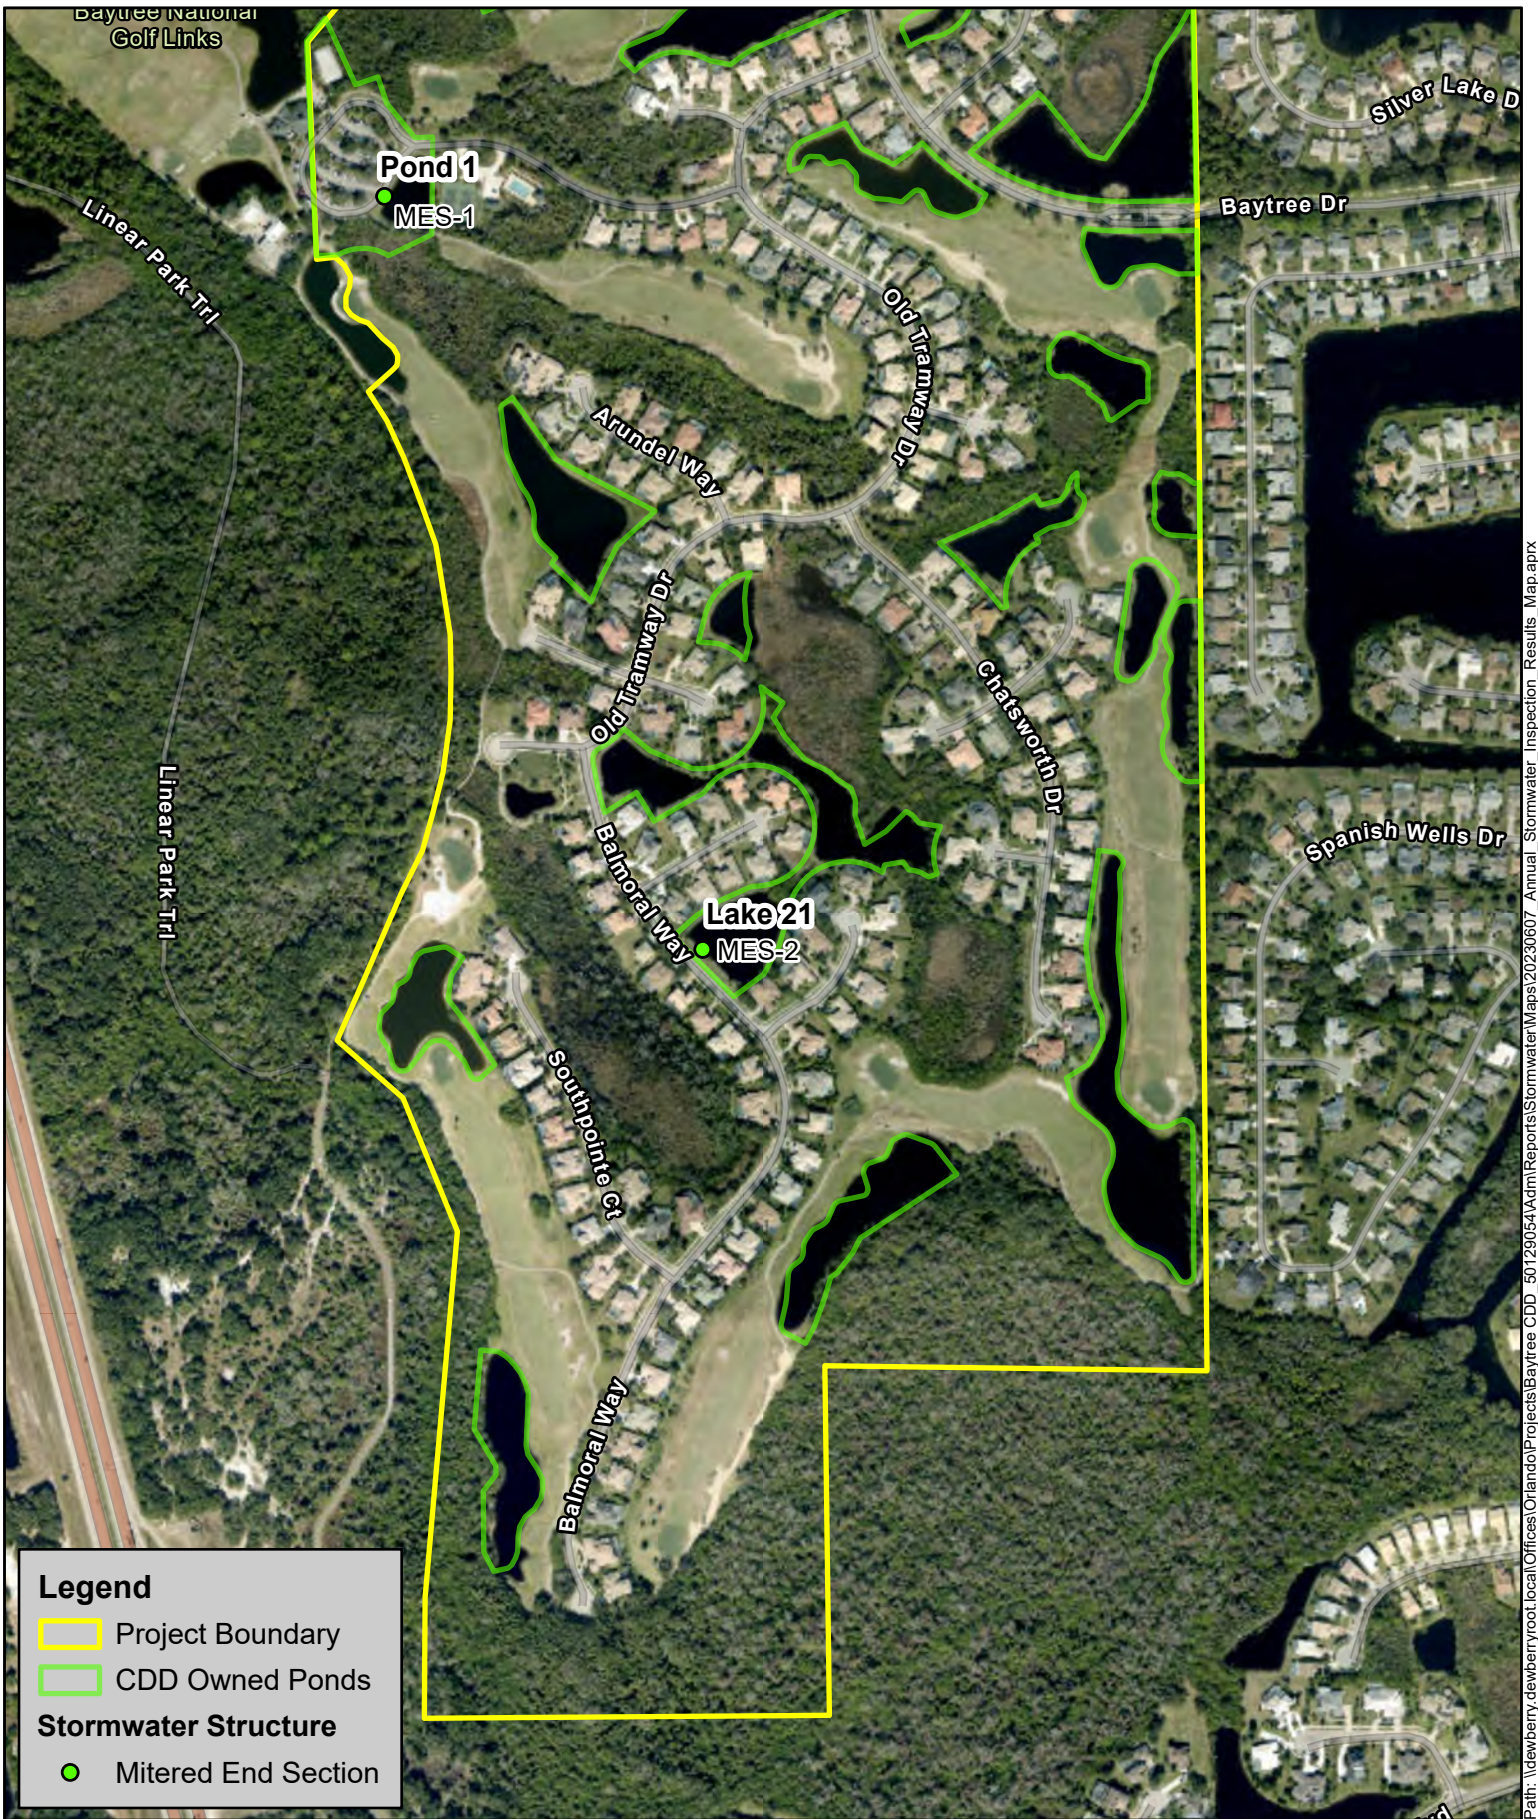
2024 Annual Stormwater Inspection Results Map

Location	Structure	Condition	Comments
Pond 1	MES-1	2 – Poor	Sedimentation buildup
Lake 21	MES-2	2 – Poor	Erosion

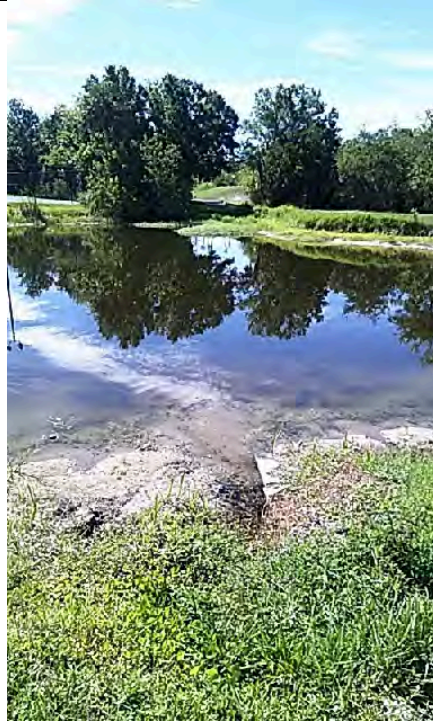
Photo 1

Location: Pond 1

Structure: MES-1

Condition: 2 – Poor

Comment: Sedimentation buildup

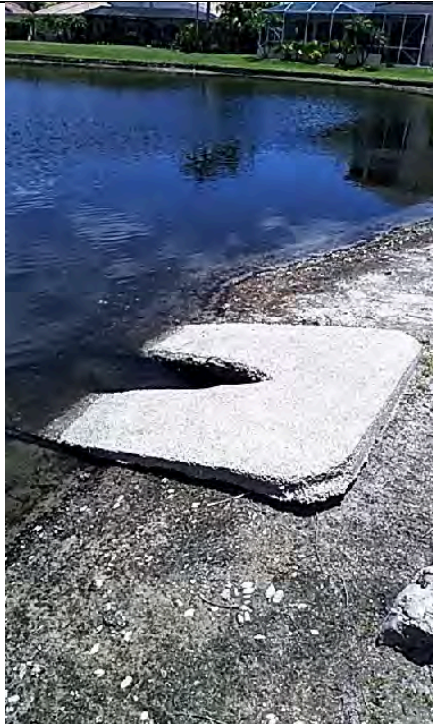
Photo 2

Location: Lake 21

Structure: MES-2

Condition: 2 – Poor

Comment: Erosion
